# **RESERVE STUDY**

**Baywood Estates Condominium Association**

Beachwood, Ohio

**Study Completed By:  
Superior Engineering - Ohio**

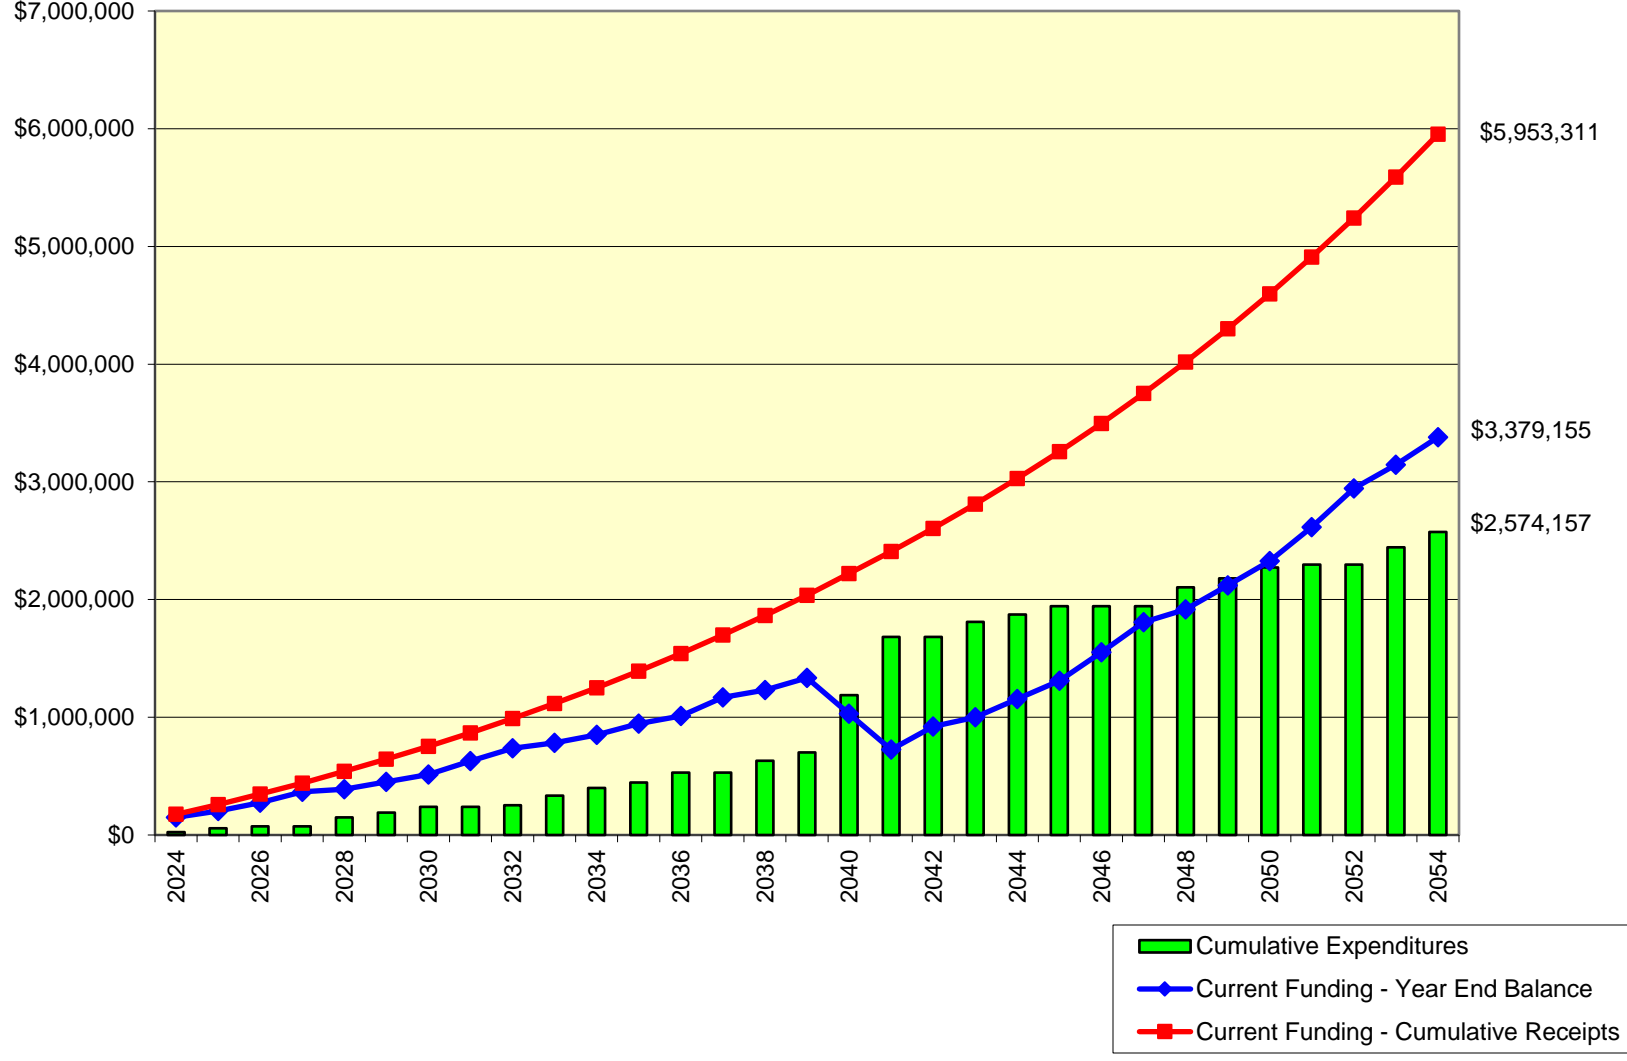
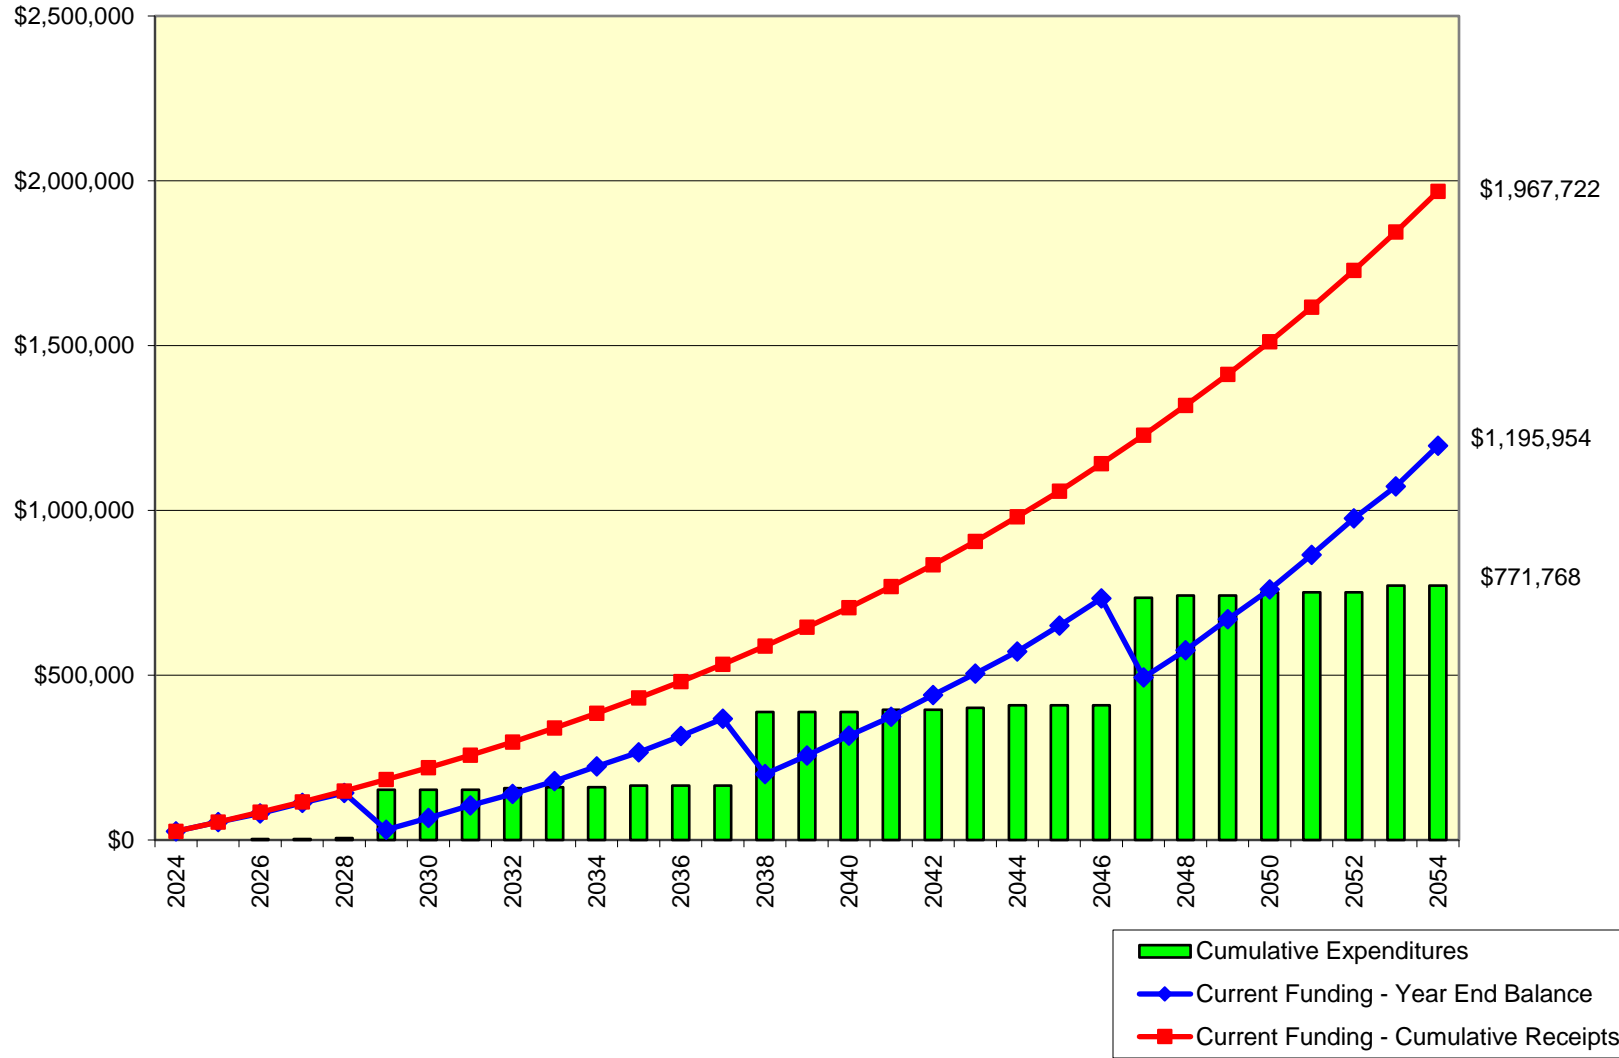
**EXHIBIT C: GRAPHS  
CURRENT ASSOCIATION FUNDING**

The graph titled "Current Association Funding" compares the Associations current funding methods, cumulative receipts and year-end balances against cumulative expenditures.

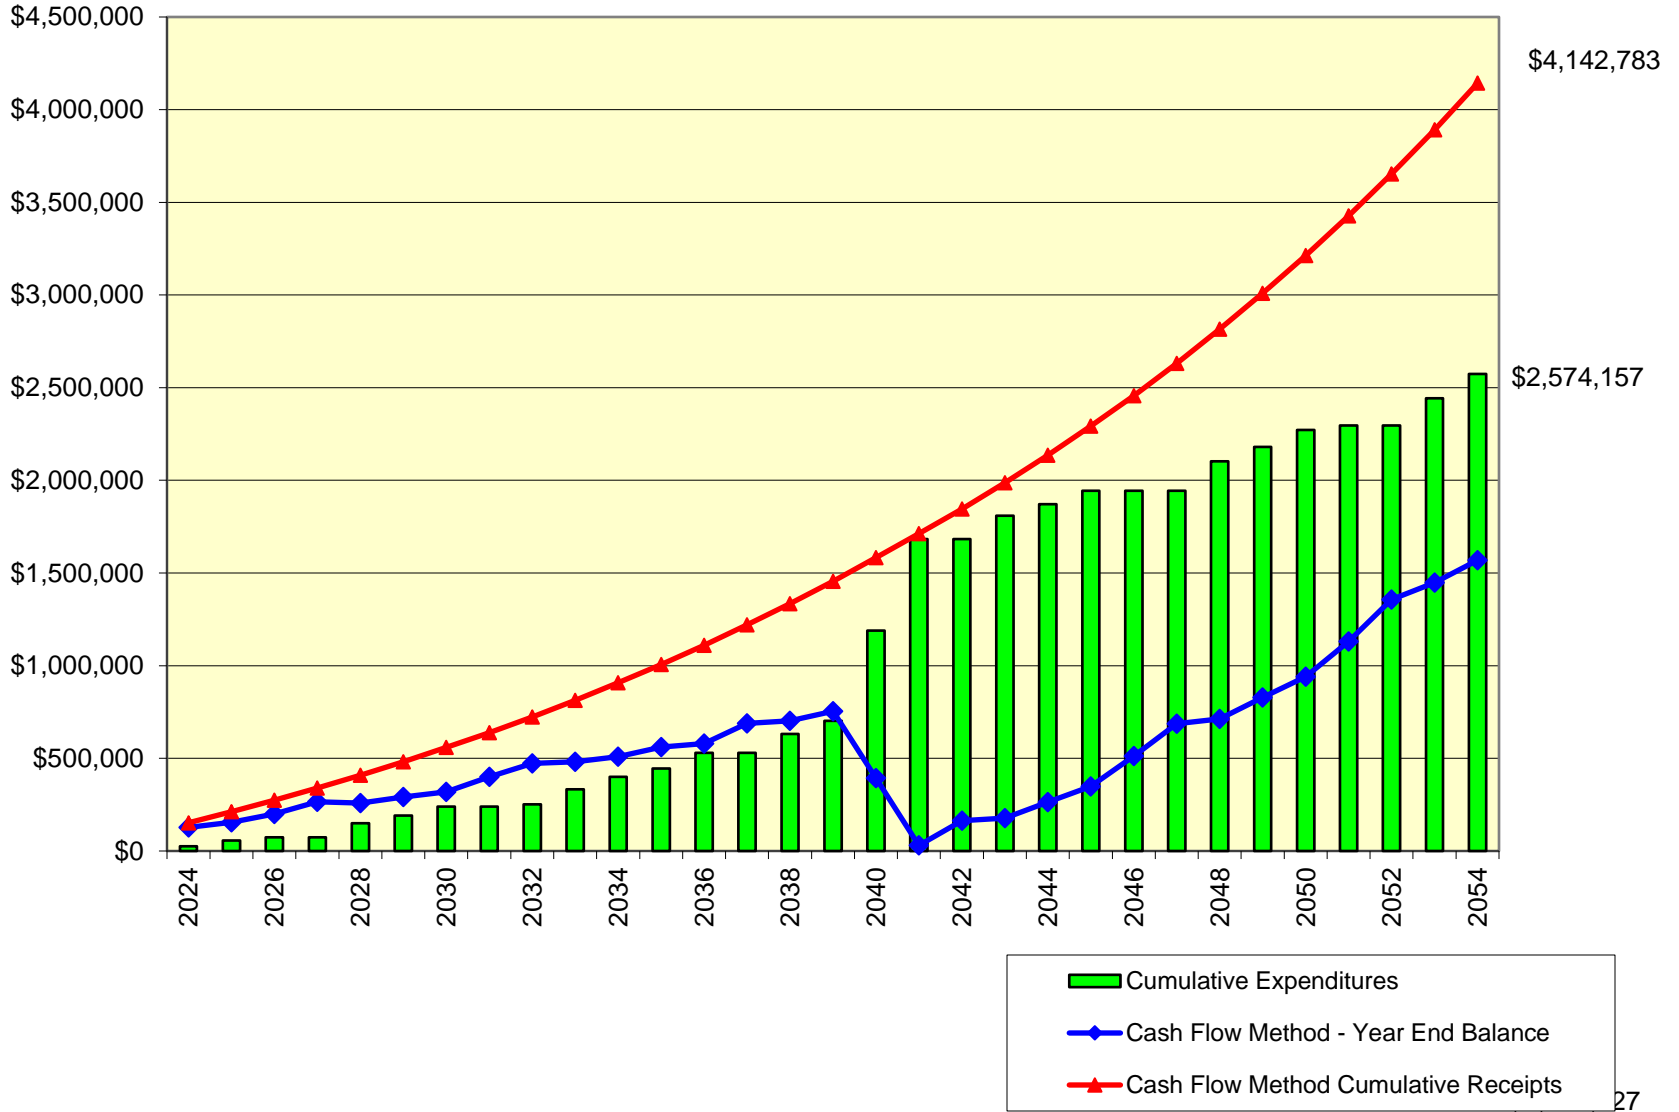
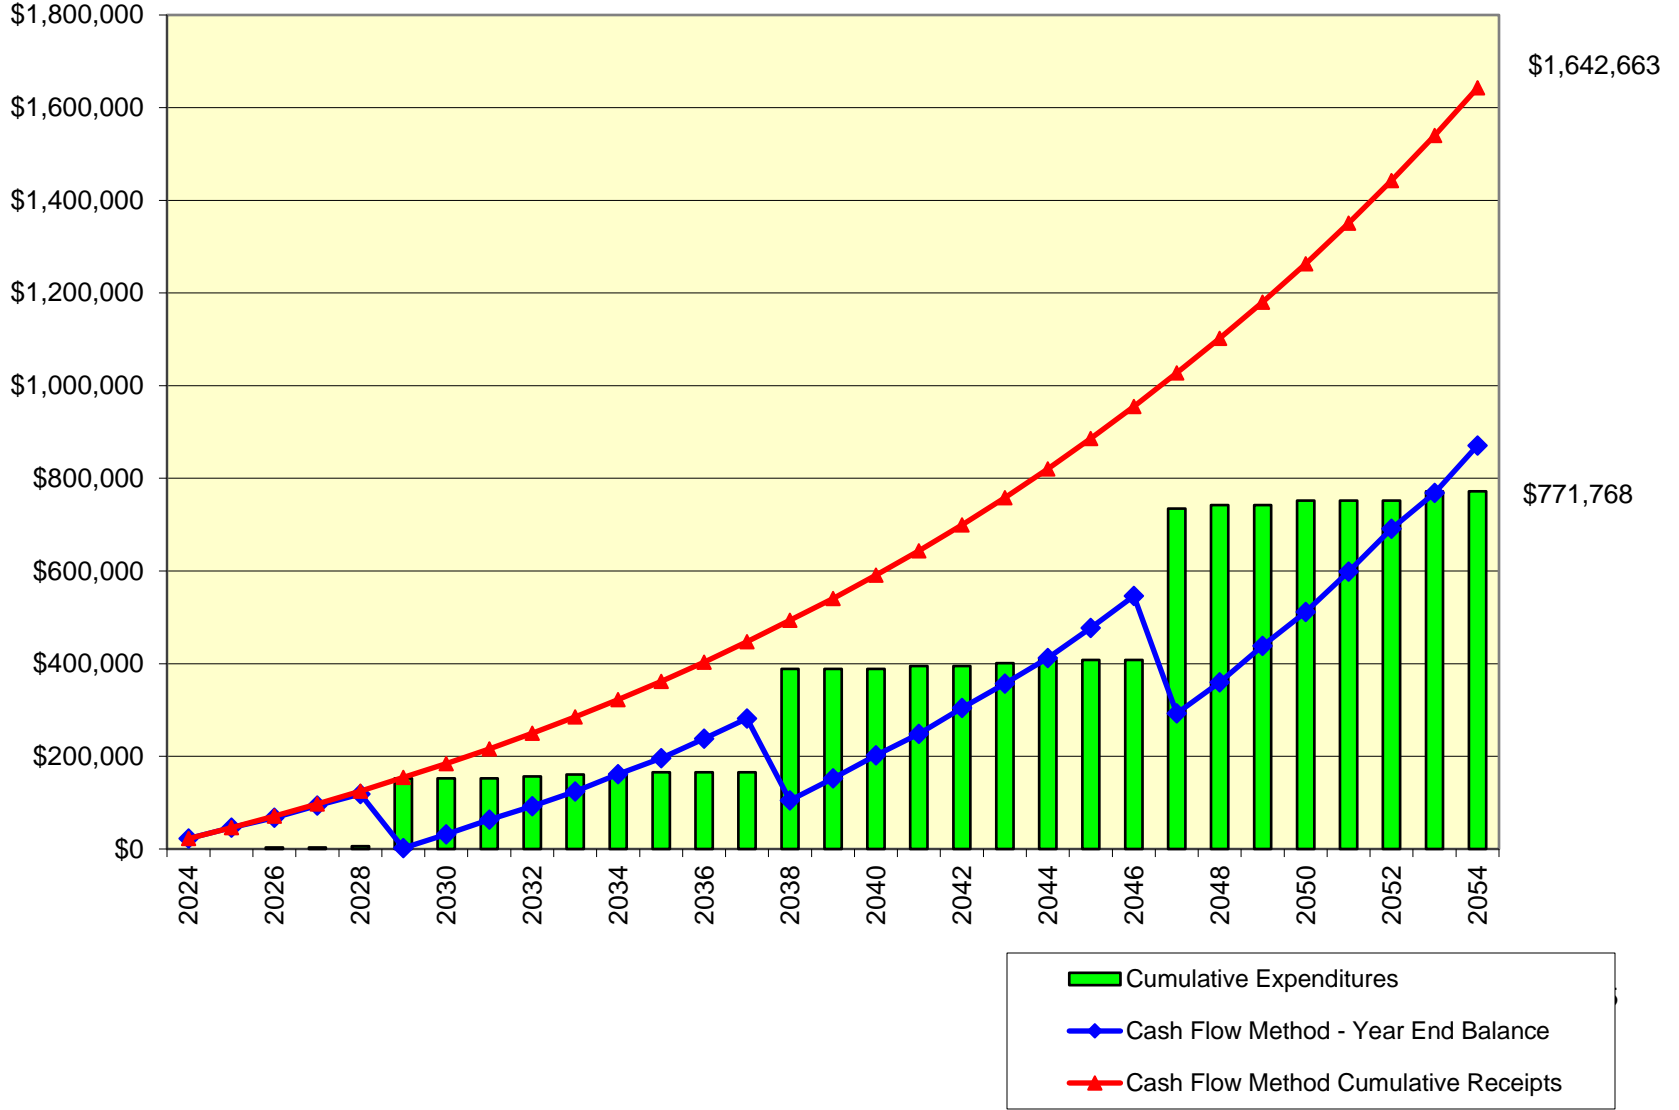
**EXHIBIT C: GRAPHS  
PROPOSED FUNDING METHOD**

The second graph titled "Proposed Funding Method" compares the proposed funding method cumulative receipts and year-end balances against cumulative expenditures.

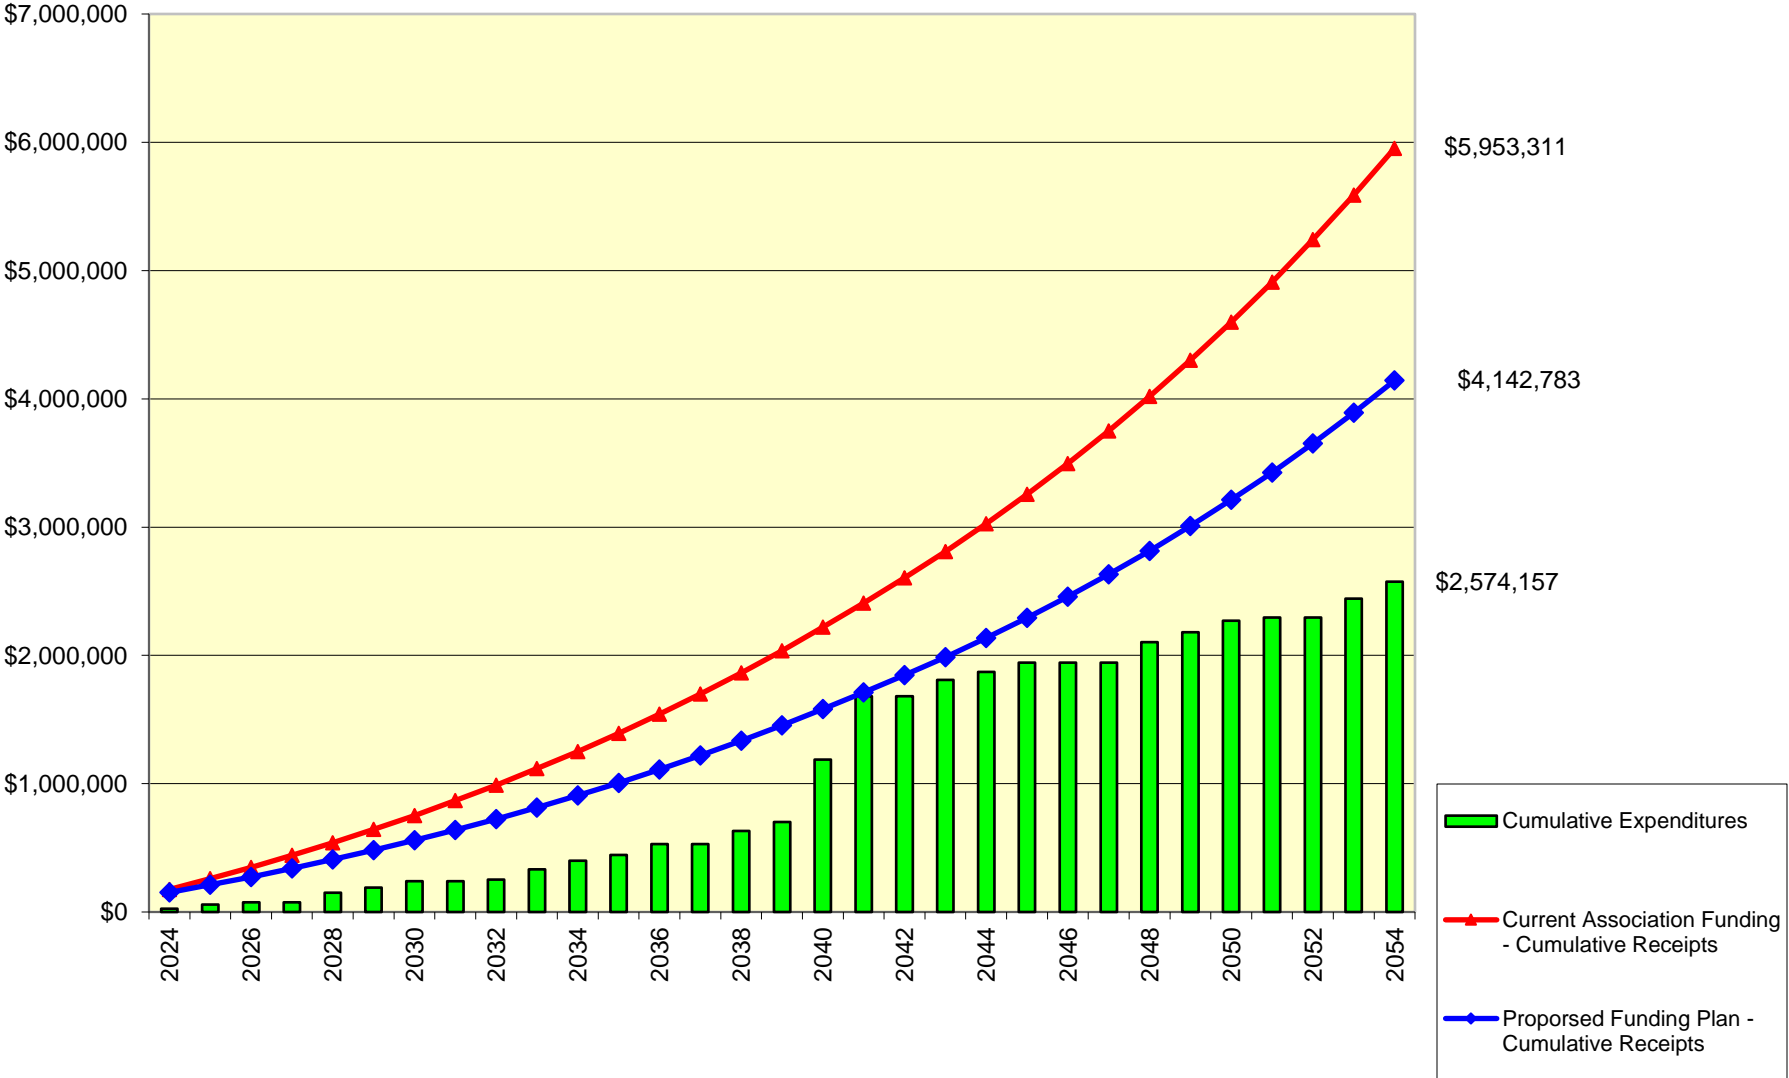
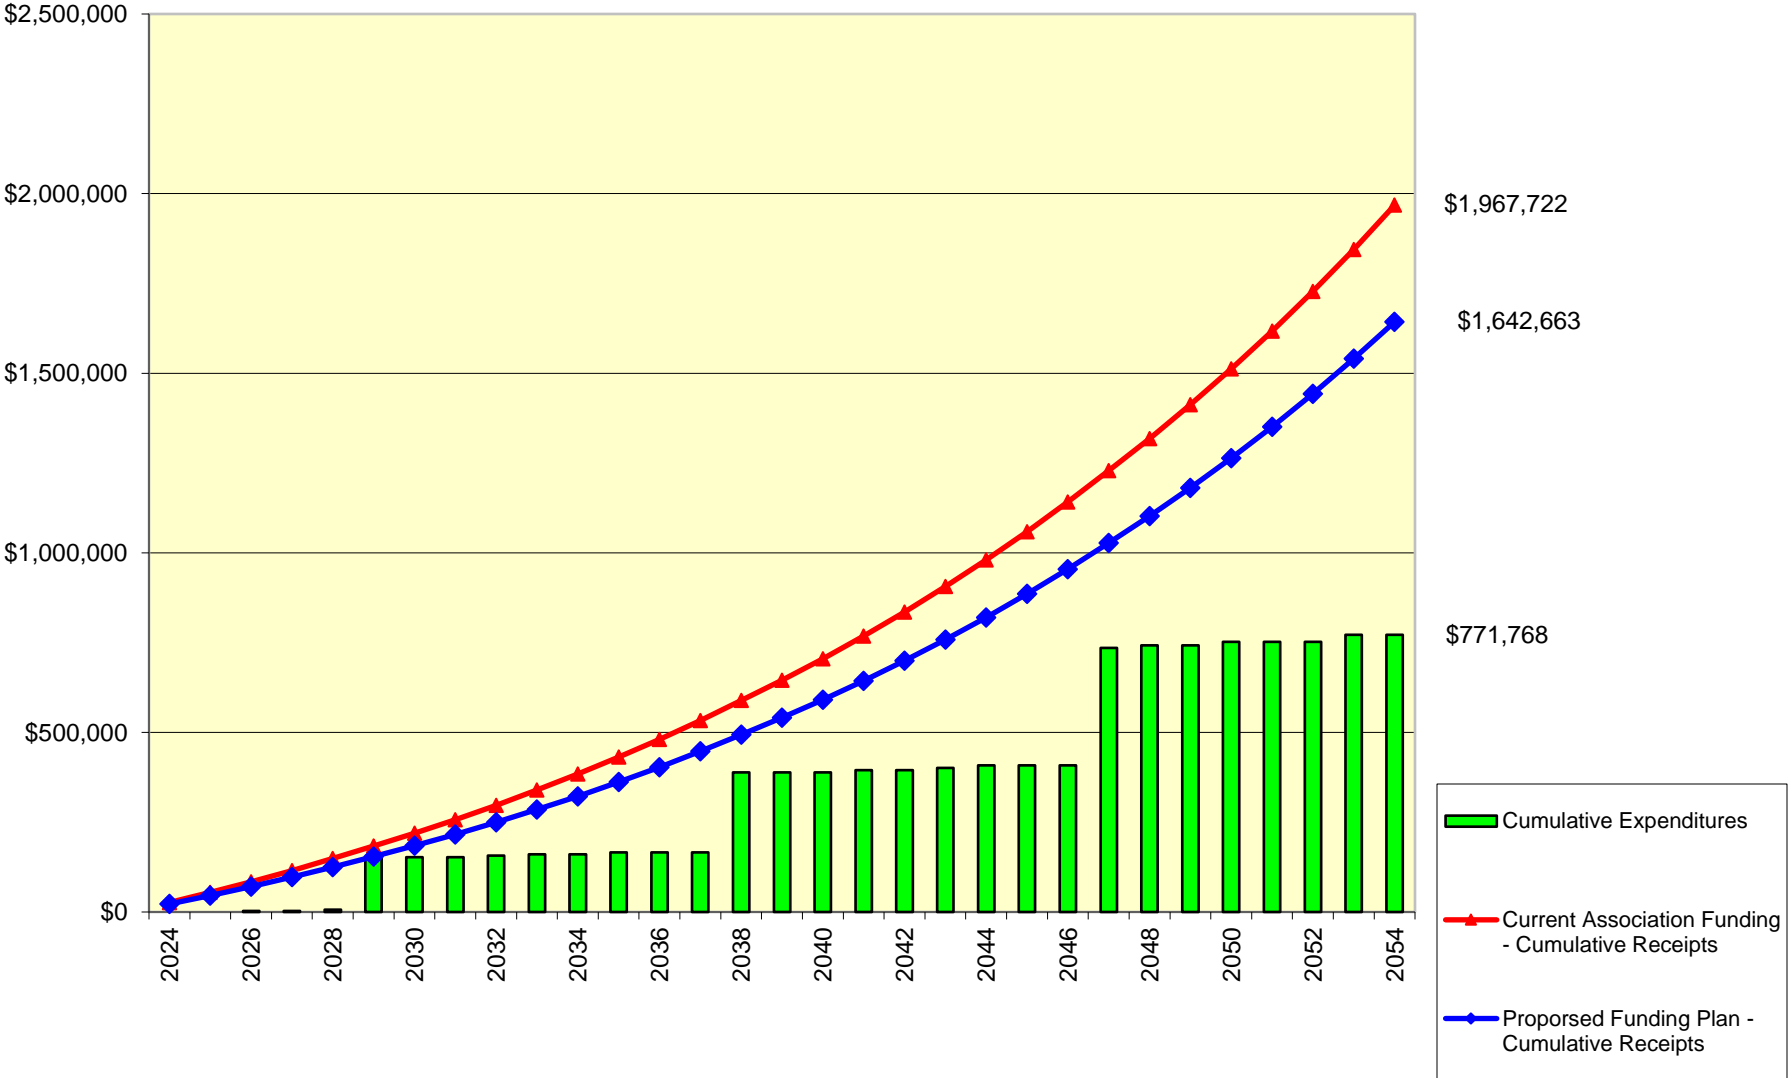
### EXHIBIT C: GRAPHS FUNDING METHOD COMPARISON

The third graph titled "Funding Method Comparison" compares the cumulative receipts of the current and proposed funding methods against the projected cumulative expenditures.
